TS² CONSULTING INC. <

November 15, 2004

INSPECTION OF EASTERN HARBOUR TUNNEL

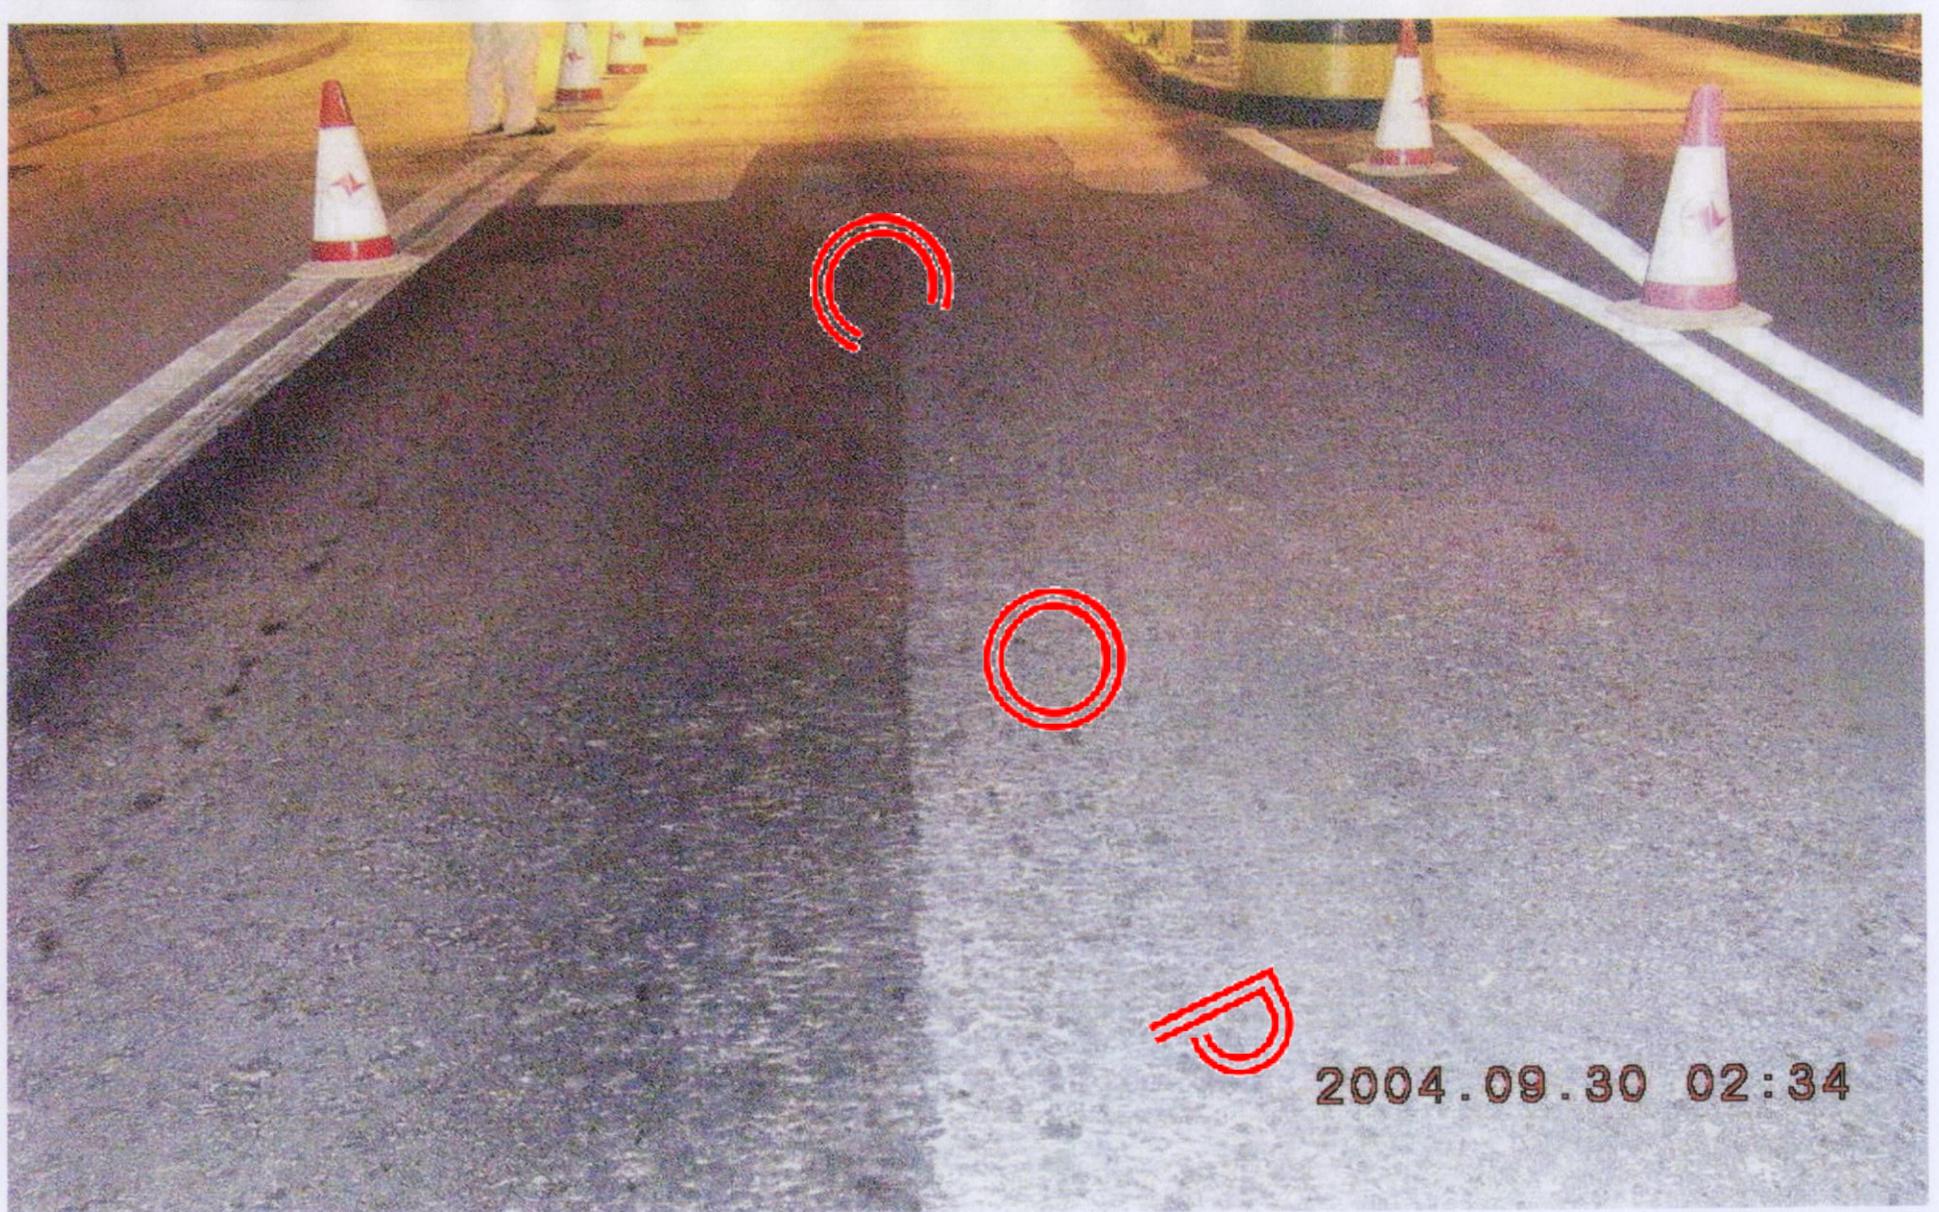
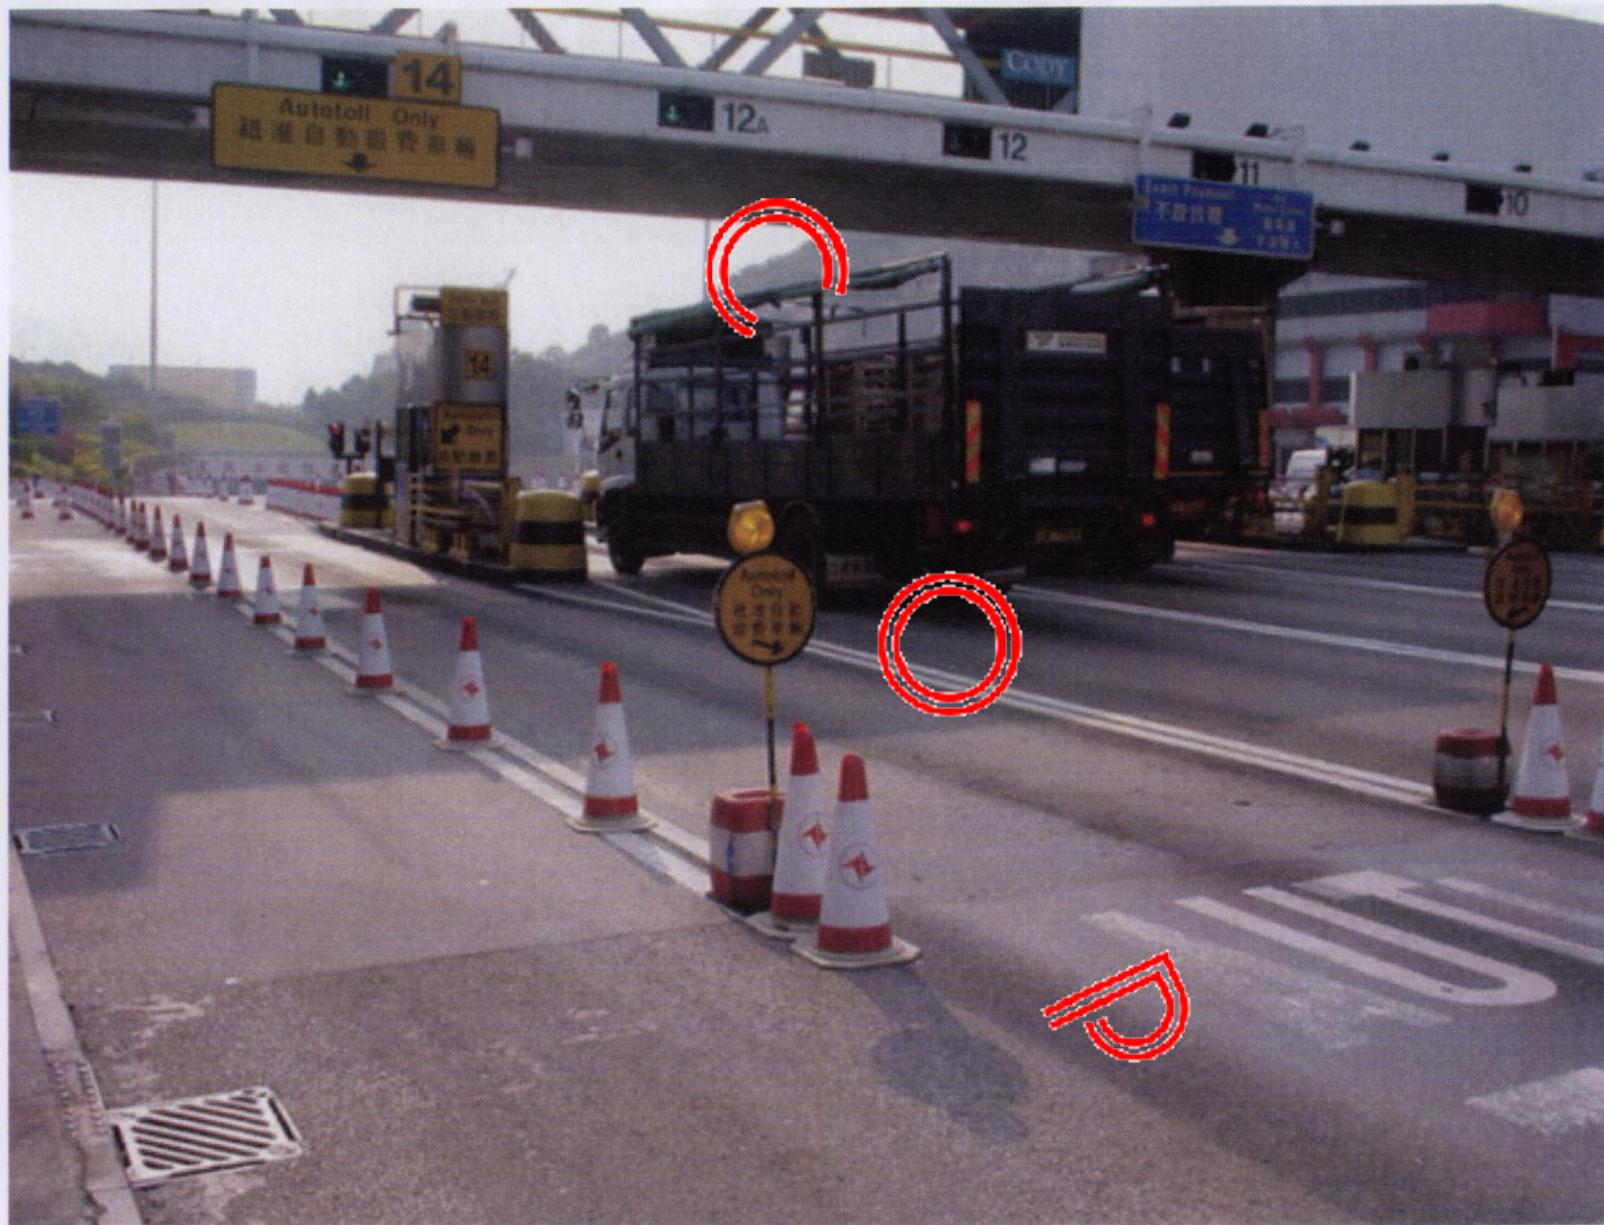
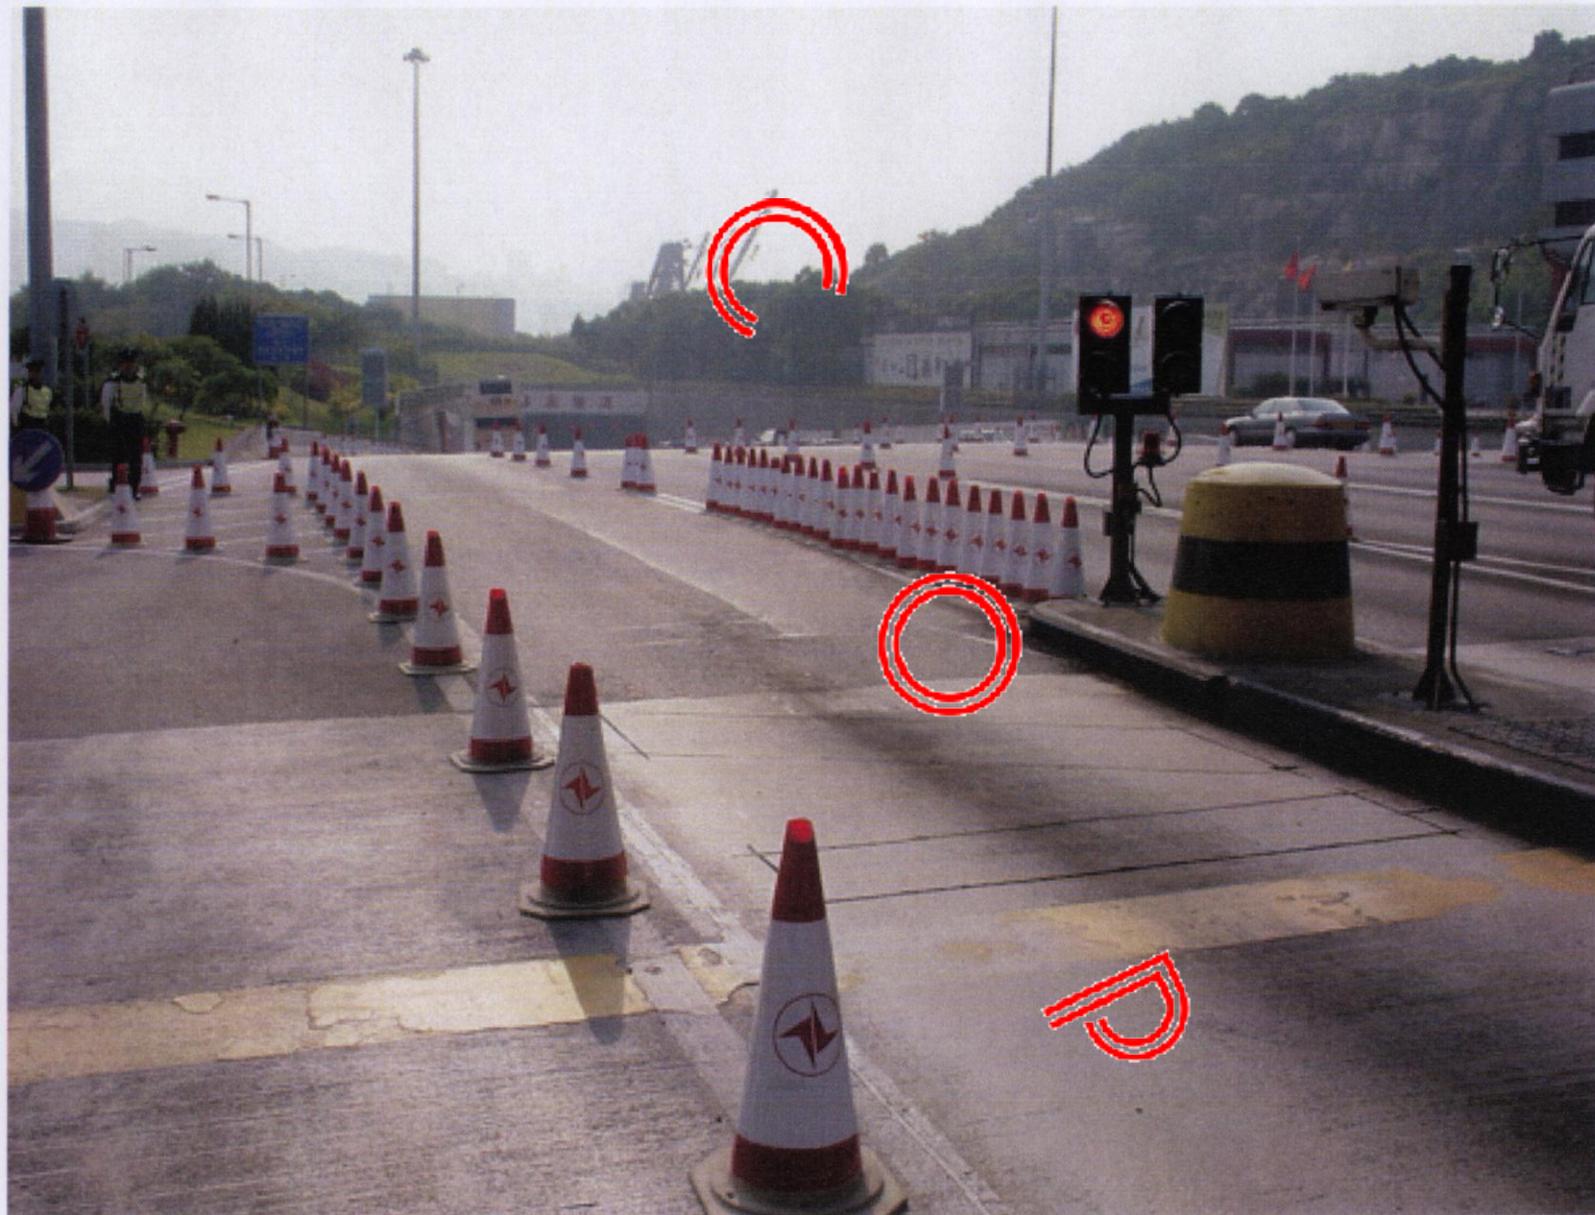
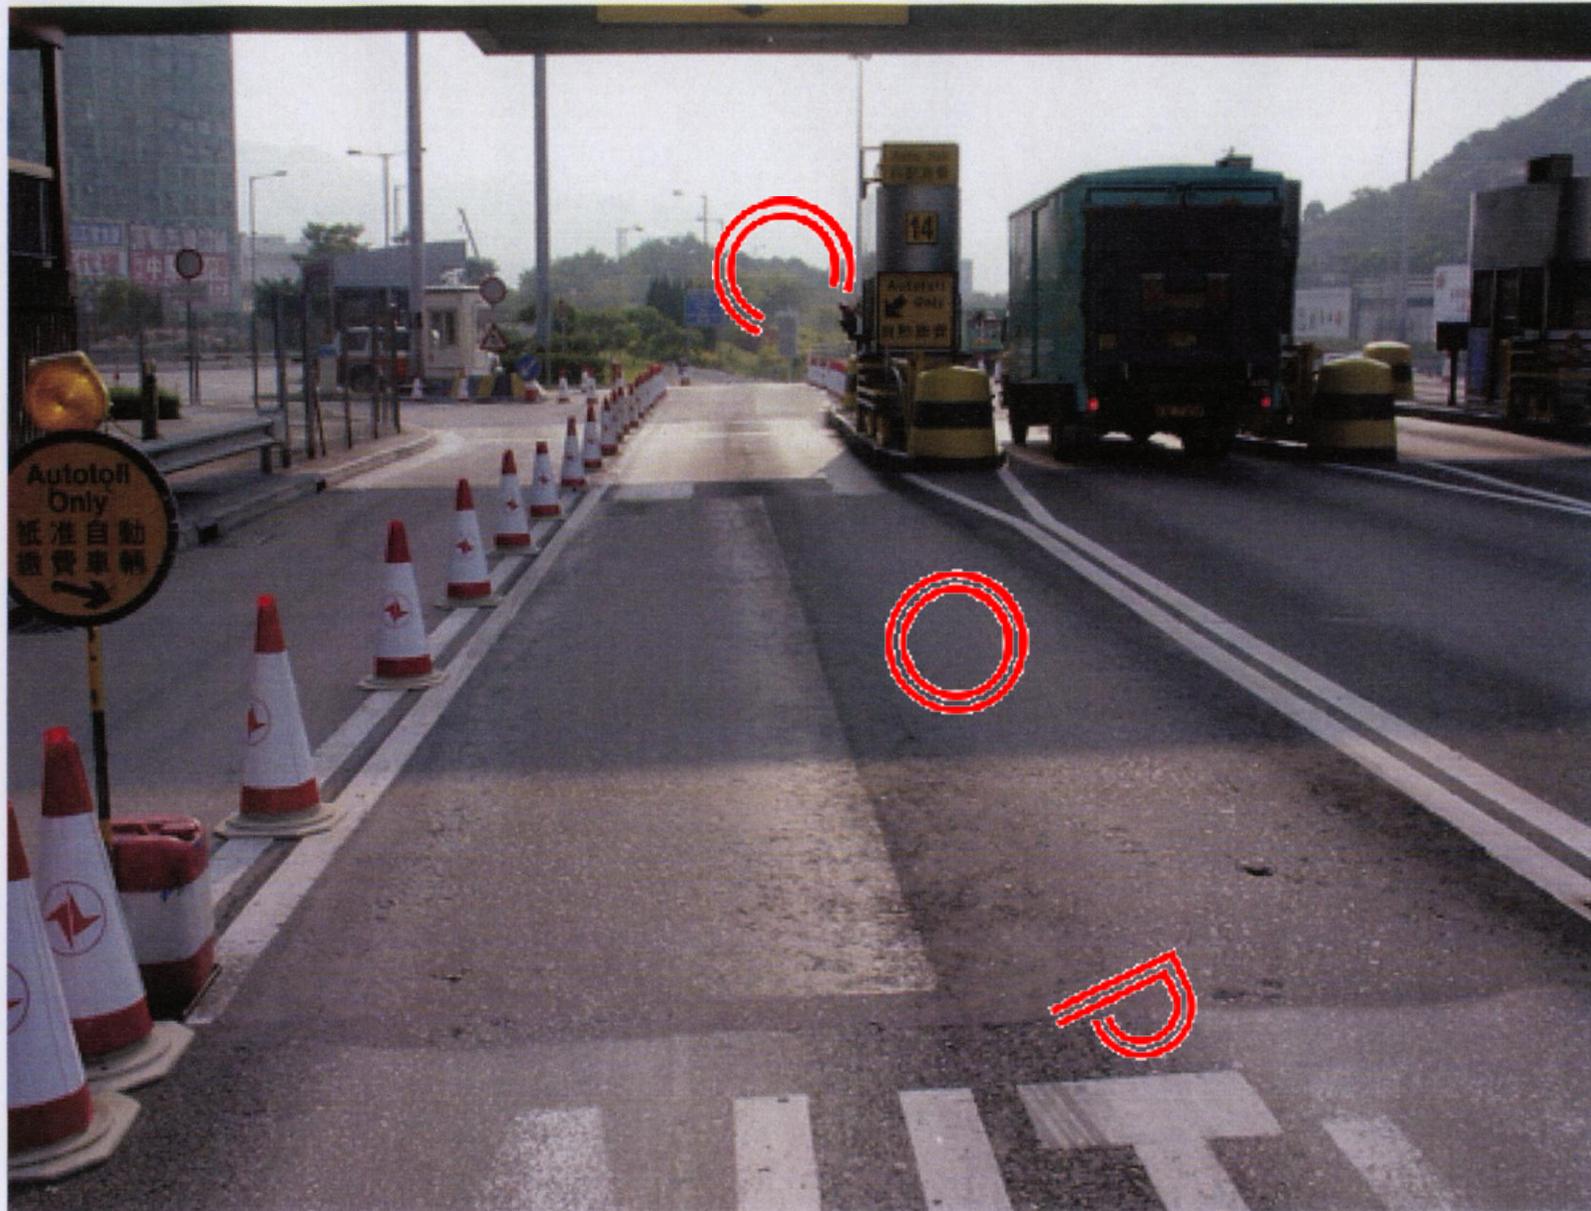
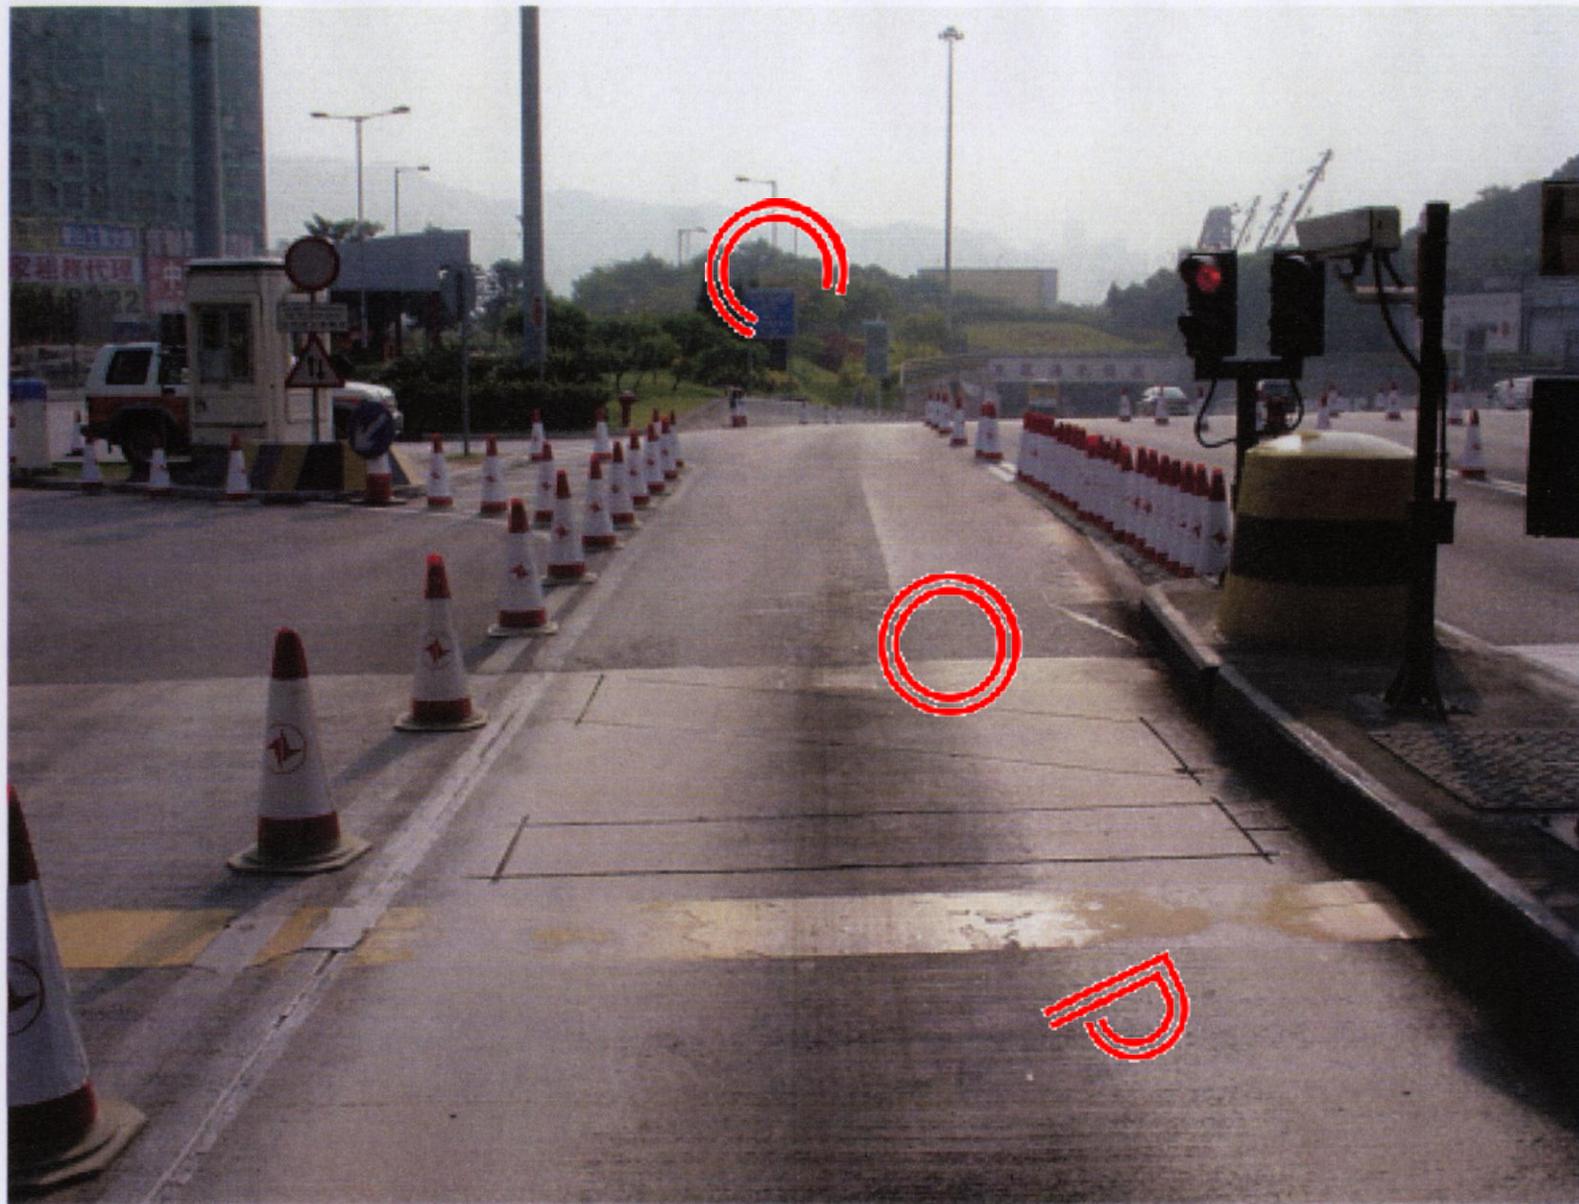
Figure 2 - Test Strip of March 5, 2004
in front of Toll Booth No. 14

Figure 2 (including 2a to 2d) illustrates the location of two demo strips that were undertaken in proximity to Toll Booth Number 14, located at the Kowloon side of the facility. This toll booth is unmanned and serves as an automatic toll collector for heavy vehicles, such as buses and trucks which travel to Hong Kong Island. Immediately in front of the toll booth, a 15-metre long strip (2 metre wide) was treated with RJSeal™ on March 5, 2004 for demonstration purposes. Similarly a 15-metre long demo strip was completed immediately after the concrete apron beside Toll Booth No 14.

The asphalt pavement at this location is a Stone Matrix Asphalt (SMA) with 25 mm aggregate at the tollbooth. Normally the pavement fails quite quickly in proximity to the tollbooths and is completely replaced every 6 to 9 months, due to the excessive traffic of heavily loaded vehicles. This is attributable to the fact, that all vehicles usually would slow down or brake in front of the Auto Toll Booth and then resume their speed, thus adding dynamic loading to the heavy static load of these vehicles, resulting in short life span of the asphalt road at about 6 to maximum 9 months. After more than 6 months, the site observation and experience with these two demo strips shows that RJSeal™ has extended the life of the asphalt pavement and still shows no significant sign of fatigue, whilst on the other side of the road surface where no RJSeal was applied, cracks are evident.

The untreated road surface showed cracks and signs of structural failure. It has to be replaced. Yet when the author went to the site in September and again in early November, the treated surface still showed no sign of fatigue or failure and raveling was negligible, as no fine loss was observed. The test proves that it can withstand the static load and induced live load of the vehicles whilst braking and accelerating.

Since there is no extensive data to identify how long the life span can be extended, the test result does suggest that RJSeal should be applied at the toll booth area at least once every 6 months. As such, it is believed that the life span of the road surface can last at least two to three more cycles, say 18 months.

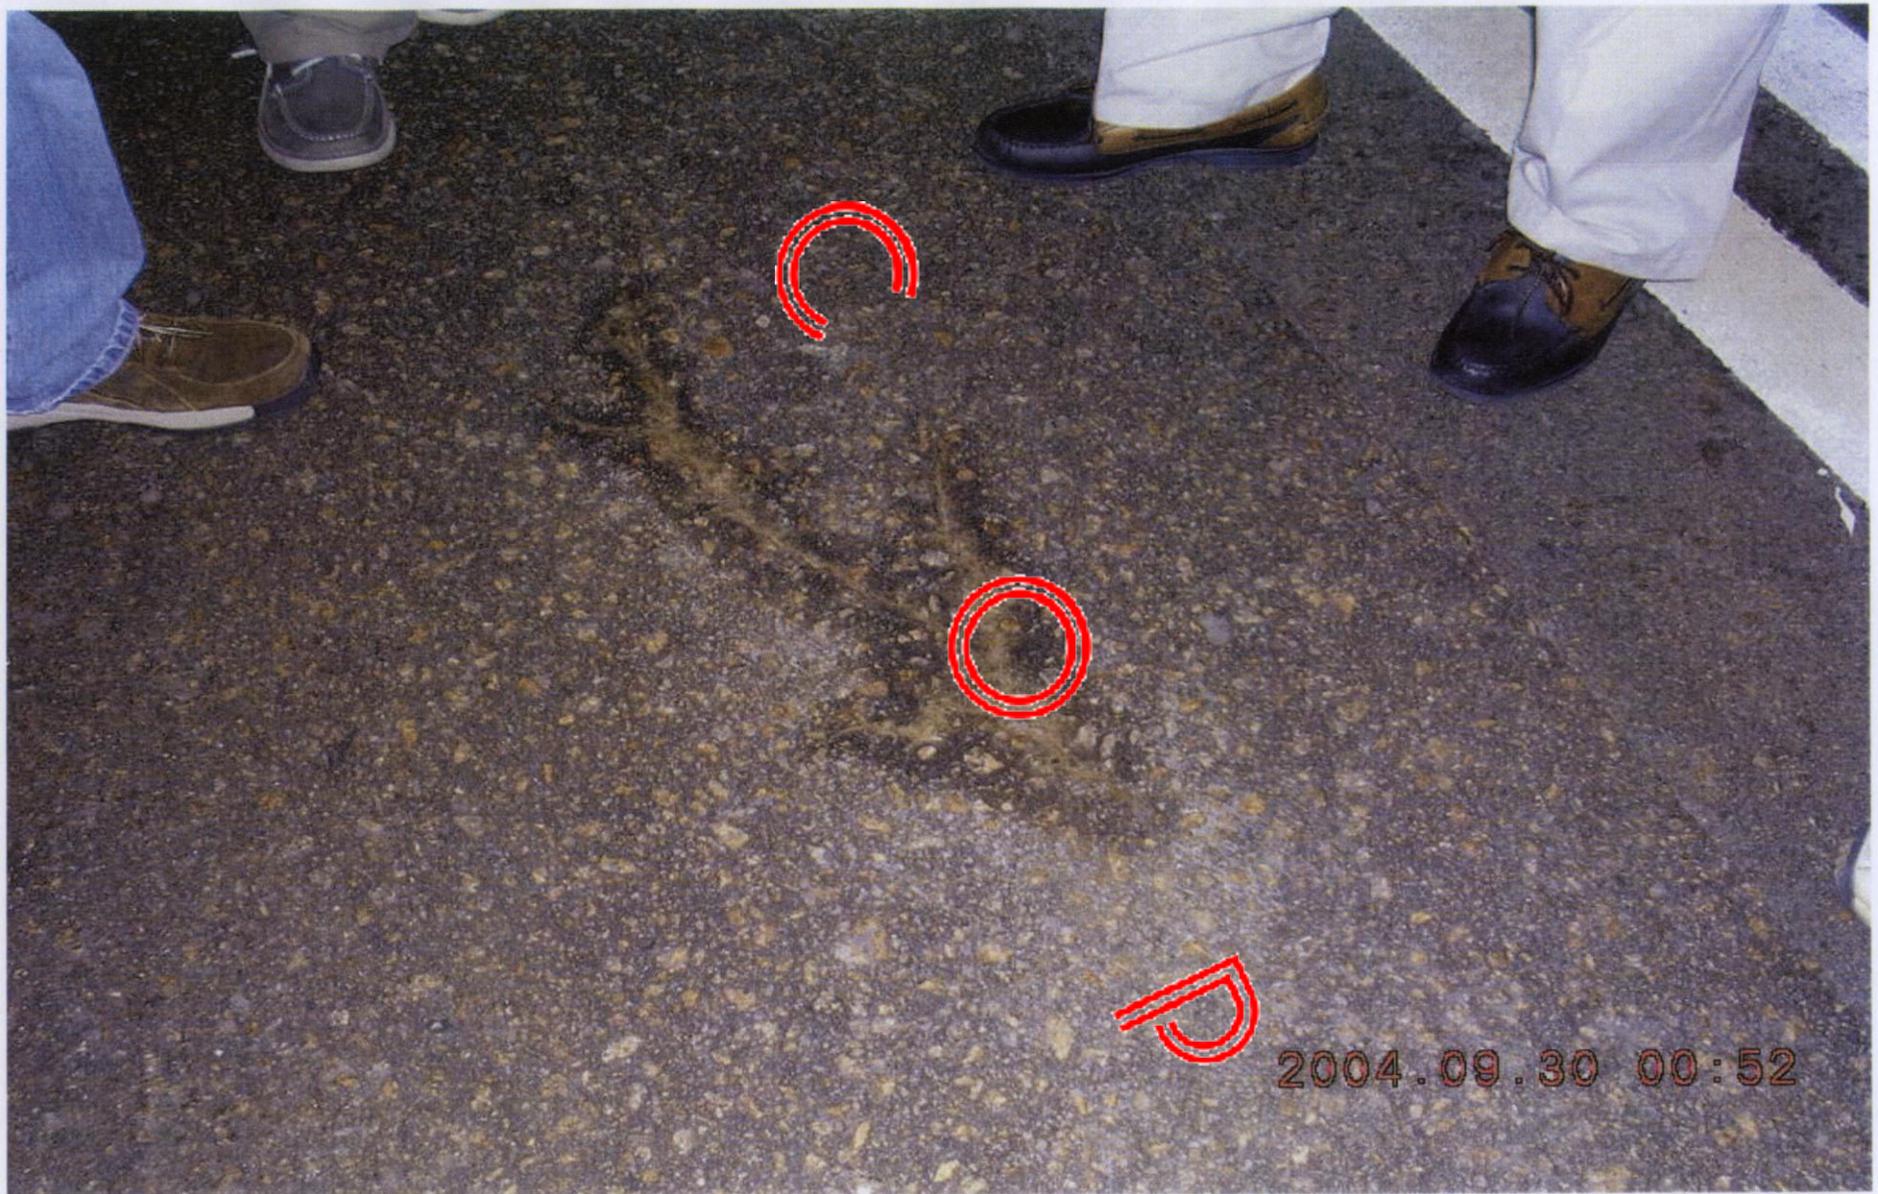
The entrance to the tunnel descends at a gradient of approximately 6% and this portion had extensive problems, with water ingress from sidewalls and floor. See [Figure 3](#) for a graphic illustration of water ingress through a porous area in the floor. Shortly after the opening of the Eastern Harbour Tunnel for service, the operating company had to install supplemental drainage down the centre of the tube (between the two driving lanes) with branch lines to the side of the tube for collection of nuisance water.

Furthermore, water percolating down the exterior skin of the tube and then arising at porous portions of the asphalt overlay results in erosion of the bitumen binder and eventually leads to the formation of honeycomb asphalt and thence potholes and local failure of the asphalt pavement. These potholes are cut out and patched on a periodic basis.

Figure 3 - Water Seepage from Floor

The general inspection of the entire Kowloon side toll area including the entrance area also suggests that some preventive measures must be undertaken in the near future to prevent further serious road surface deterioration of the structures.

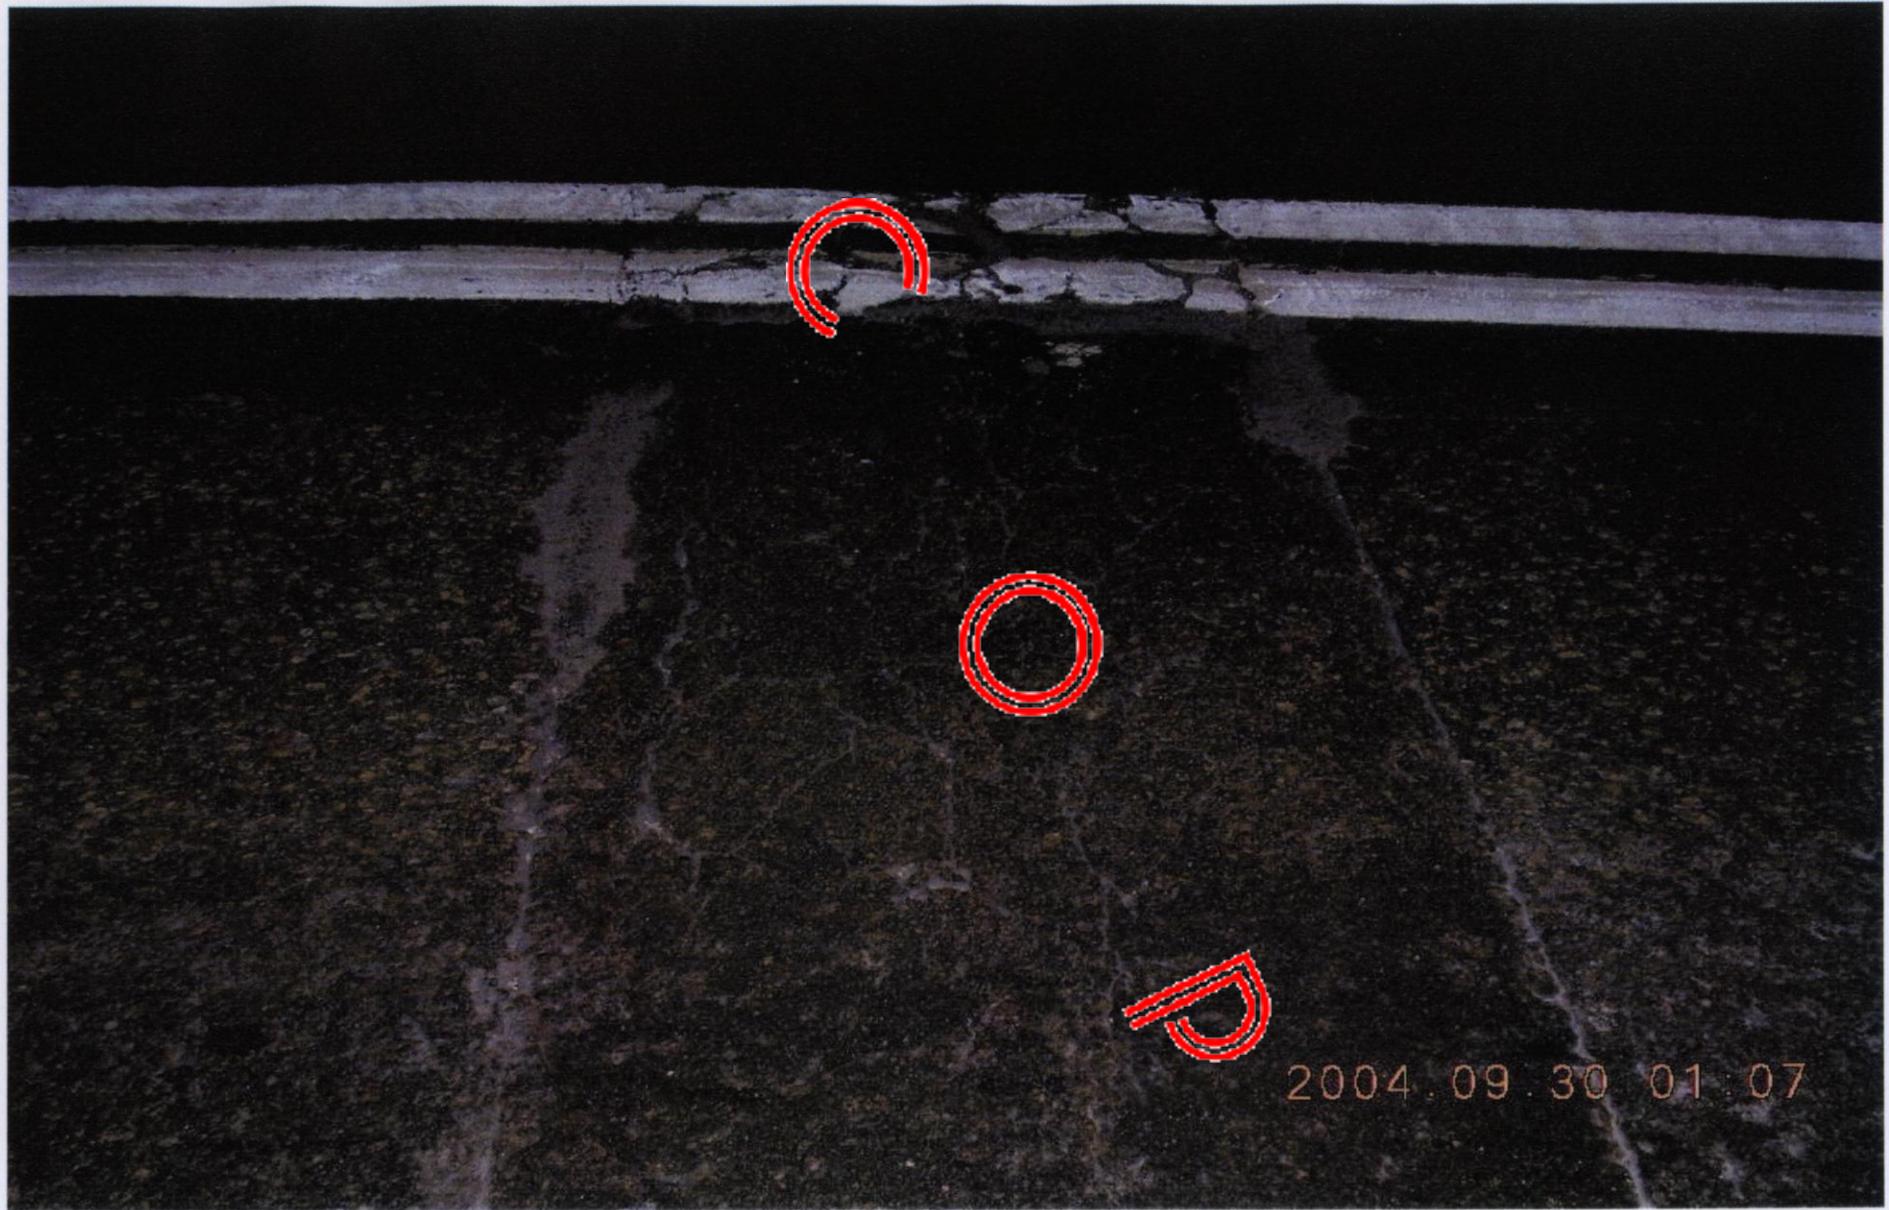
The drainage system that was retrofitted, post-completion also has presented some maintenance problems due to flexure of the asphalt pavement that overlies the cross drains from the central collector. See [Figure 4](#) for illustration of the asphalt failure at the cross drain. This is especially prominent in the initial portion of the tunnel at the decline on the way down to the level central portion. Inspection of the asphalt pavement in the central portion shows no significant problems, although in the wheel path of both lanes, there is a raveling (loss of fines and exposure of the stone matrix).

Figure 4 - Damaged Asphalt at Cross Drain

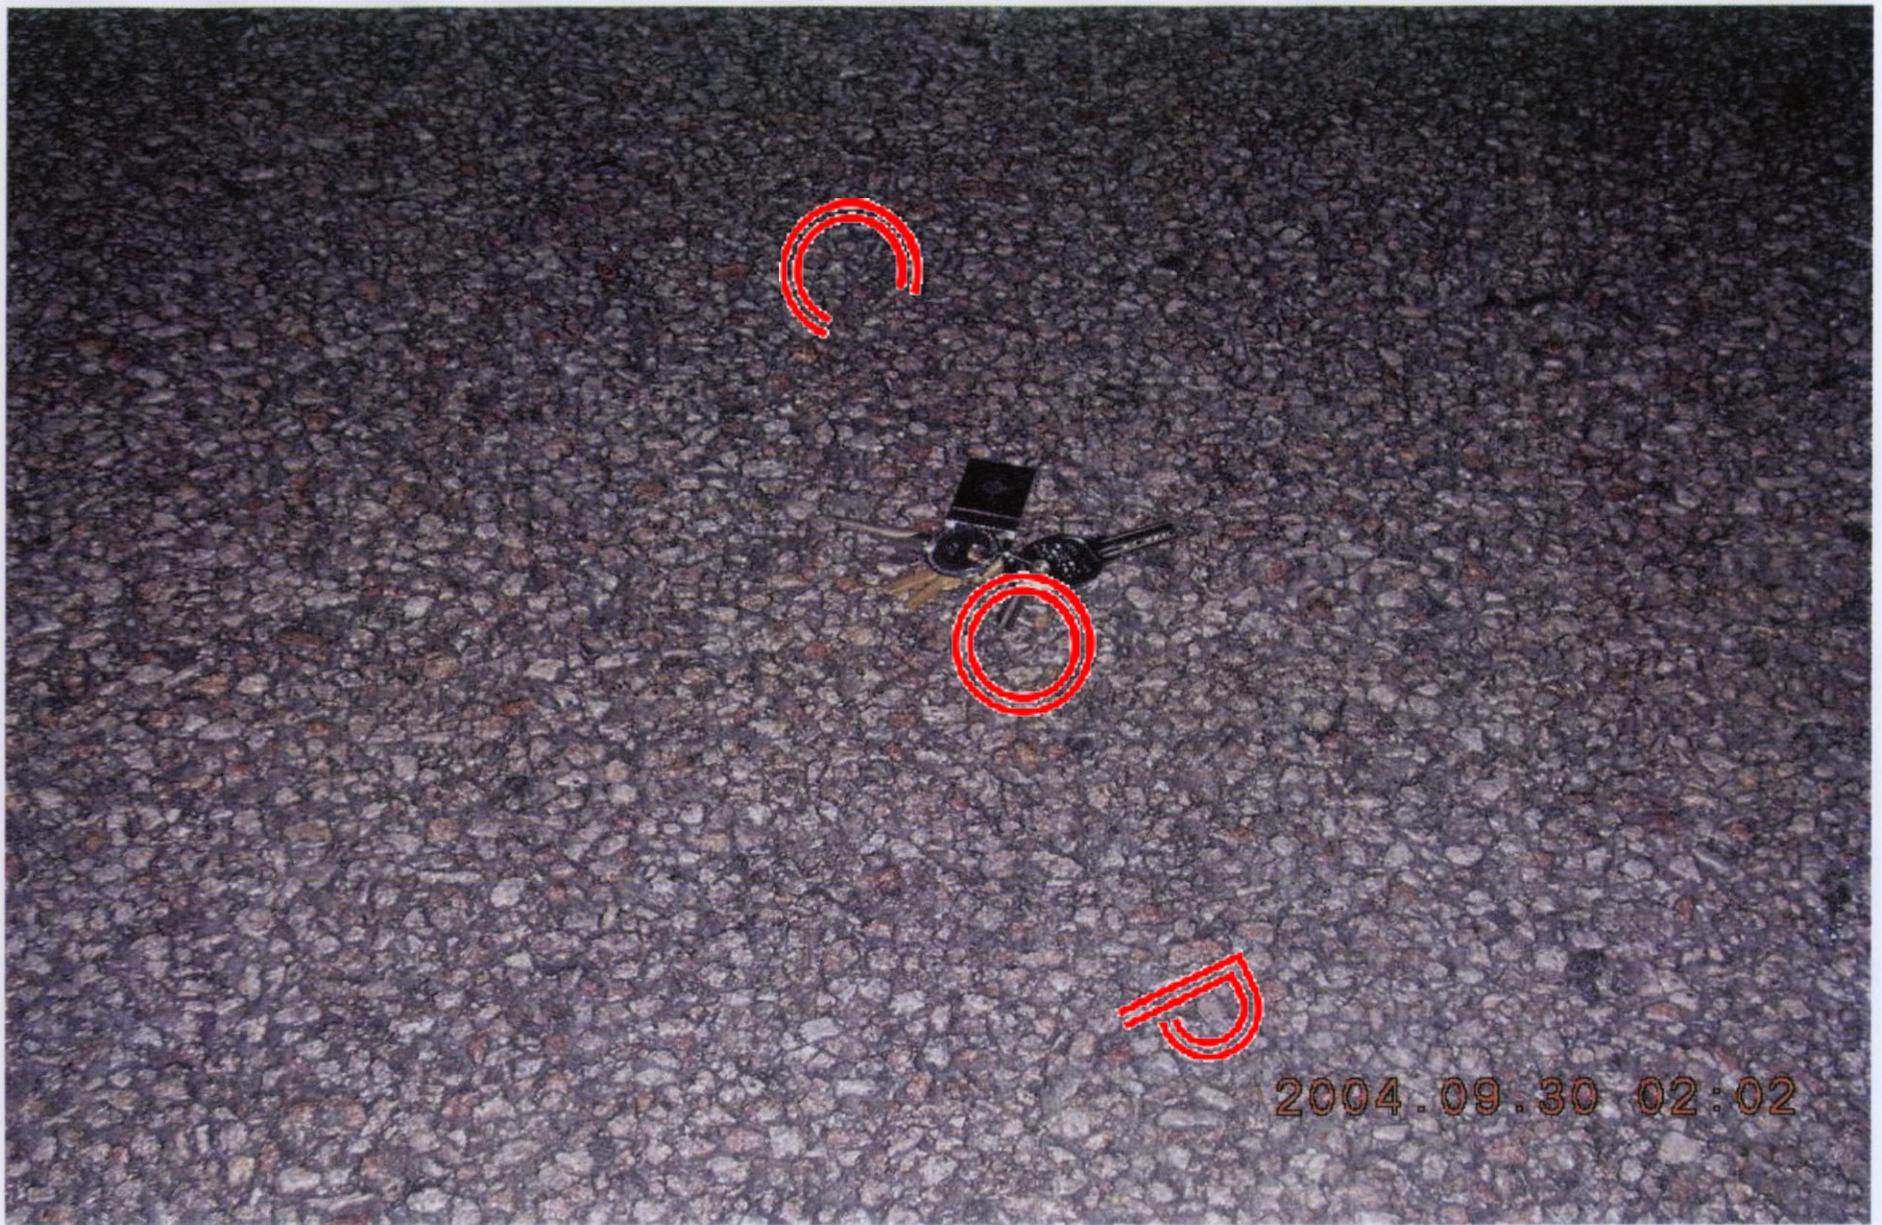
See [Figure 5](#) illustrating the exposure of the stone matrix. At the present time, the exposed stones have sufficient bitumen binder to hold them in place, but it is suspected that in the next year, some maintenance material should be applied to rejuvenate the bitumen, which is now quite stiff. Attempts to dig into asphalt pavement with a pocketknife indicate that the bitumen binder is now quite inflexible.

Figure 5 - Exposed Pebbles in Asphalt Pavement
