TS² CONSULTING INC. <

November 15, 2004

INSPECTION OF EASTERN HARBOUR TUNNEL

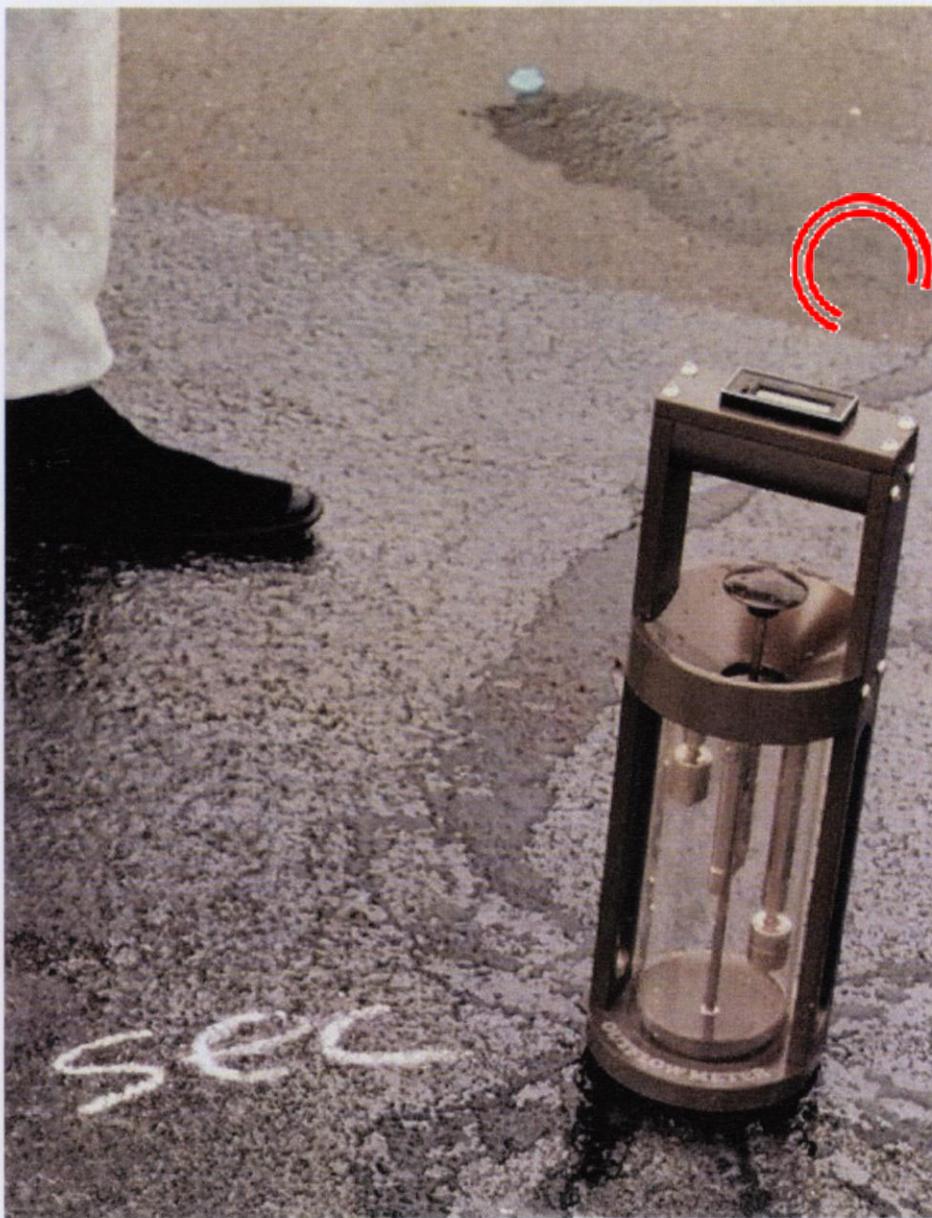
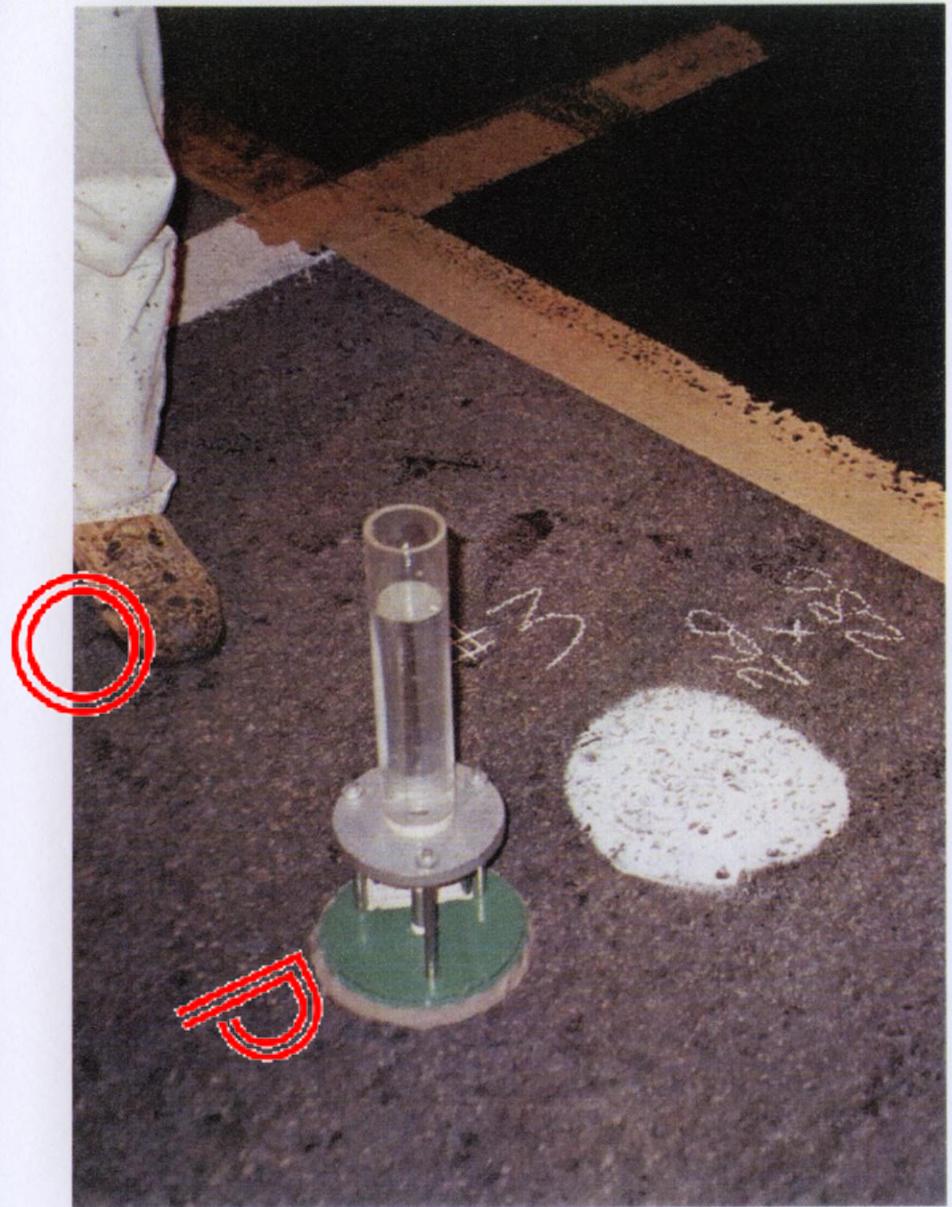
The following test procedures were implemented to test the asphalt pavement. Figure 6 shows the suggested type of equipment that can be used for the various test procedures. Comparisons were undertaken at several locations on both the untreated and RJSeal™ treated sections (see Figure 7).

Figure 6 - Humble Equipment Co. Outflow ~~Meter~~
Water Penetration Meter & Sand Patch Test

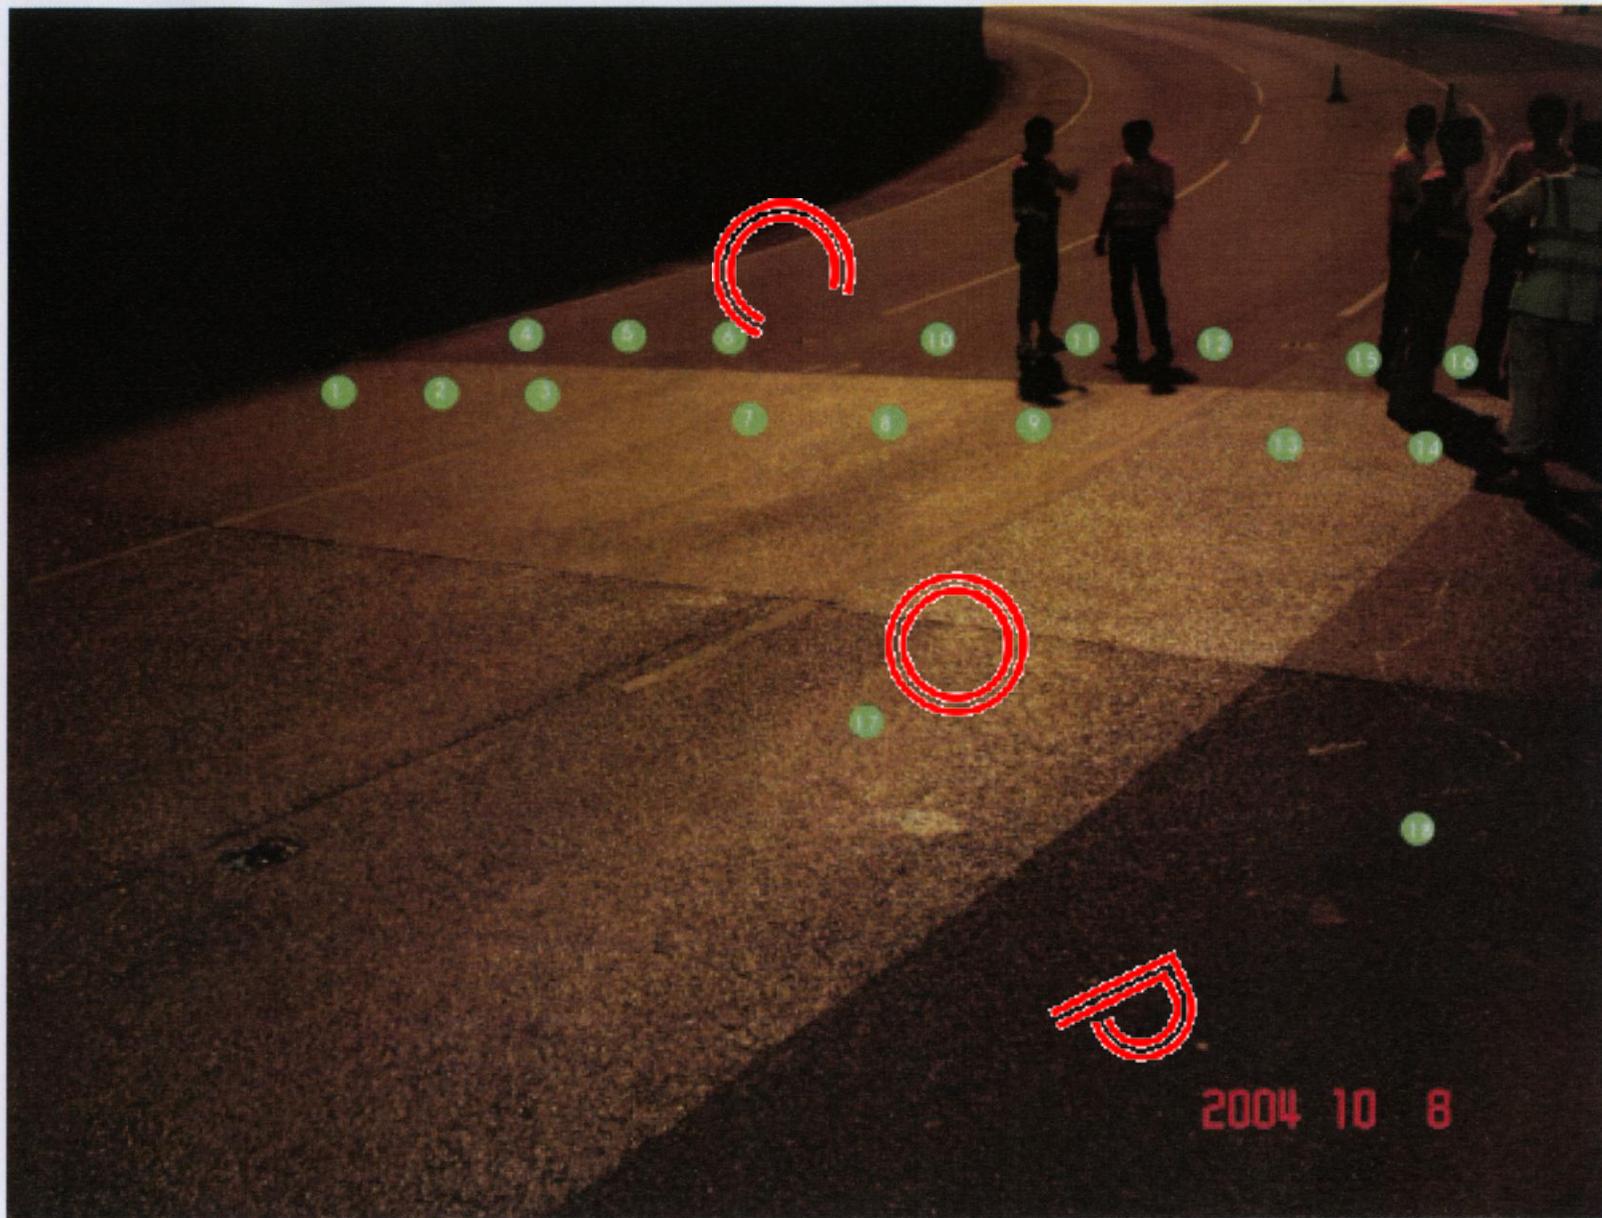
The untreated road surface showed cracks and signs of structural failure. It has to be replaced. Yet when the author went to the site in September and again in early November, the treated surface still showed no sign of fatigue or failure and raveling was negligible, as no fine loss was observed. The test proves that it can withstand the static load and induced live load of the vehicles whilst braking and accelerating.

Figure 7 - Locations of RJSeal™ Treated and Untreated Sections
